EXAMINATION OF CORRODED TUBES FROM THE BOILERS OF THE USS EDWARDS (DD-950)

August 1959

U. S. NAVAL RESEARCH LABORATORY
Washington, D.C.

NRL MEMORANDUM REPORT 964

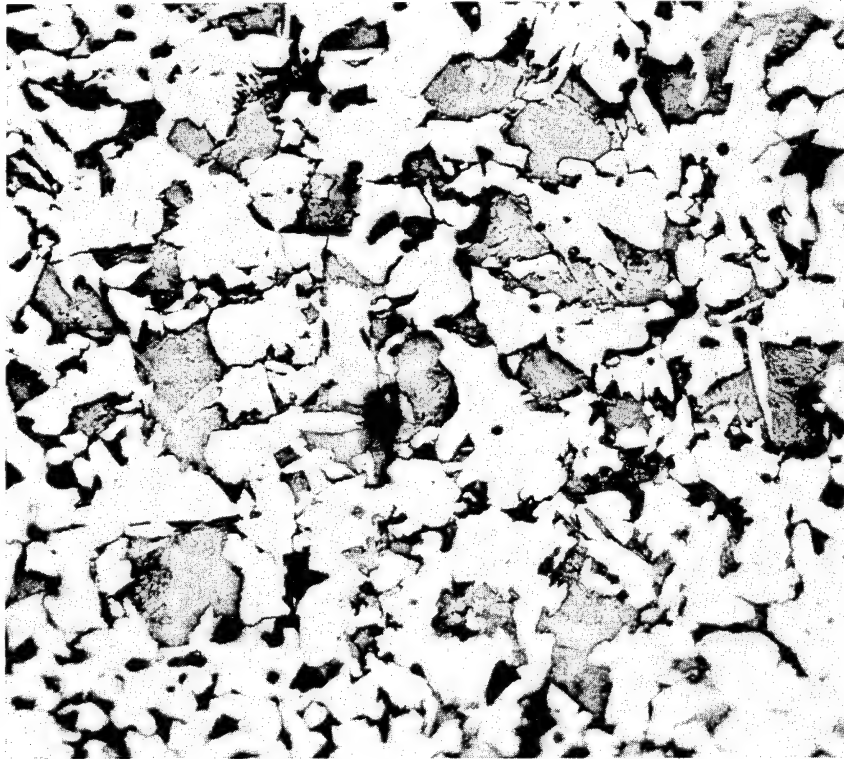
- Fig. 2 - 1B Boiler - RW No. 21 (Section through bulge that had cracked). Notice structure indicating that metal was rapidly cooled from temperature above 1335°F when the tube failed. Etchant: 1% Nital. 1000X.

Fig. 2 - 1B Boiler - RW No.21 (Section through bulge that had cracked). Notice structure indicating that metal was rapidly cooled from temperature above 1335° F when the tube failed. Etchant: 1% Nital. 1000X.

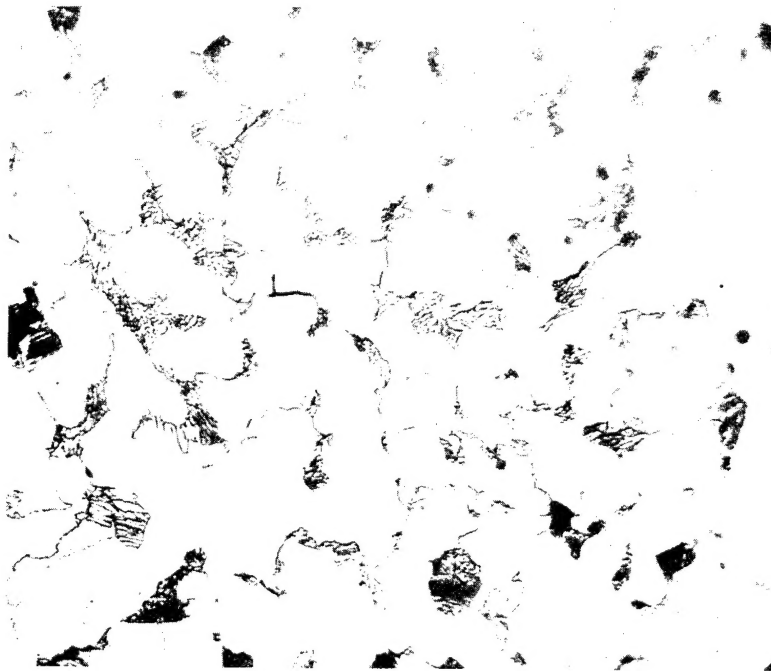
- Fig. 3 - 1B Boiler - RW No. 18 (Section through bulge that had not cracked). Note lamellar (new) pearlite which indicates that service temperature exceeded 1335°F. Etchant: 1% Nital plus 2% Picral. 1000X.

Fig. 3 - 1B Boiler - RW No.18 (Section through bulge that had not cracked). Note lamellar (new) pearlite which indicates that service temperature exceeded 1335⁰F. Etchant: 1% Nital plus 2% Picral. 1000X.

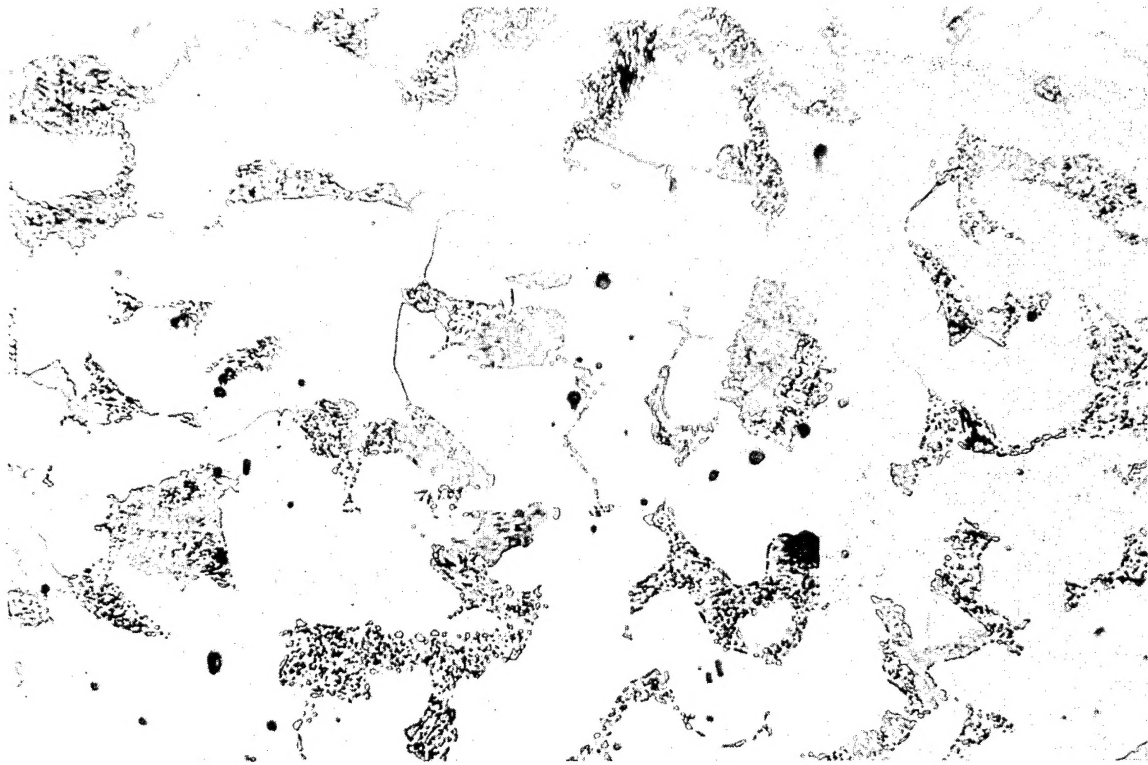
- Fig. 4 - 1B Boiler - RW No. 18 (Section adjacent to bulge). Note coarse carbides; no evidence of partial austenitization is present. Etchant: 1% Nital plus 2% Picral. 1000X.

Fig. 4 - 1B Boiler - RW No. 18 (Section adjacent to bulge). Note coarse carbides; no evidence of partial austenitization is present. Etchant: 1% Nital plus 2% Picral. 1000X.

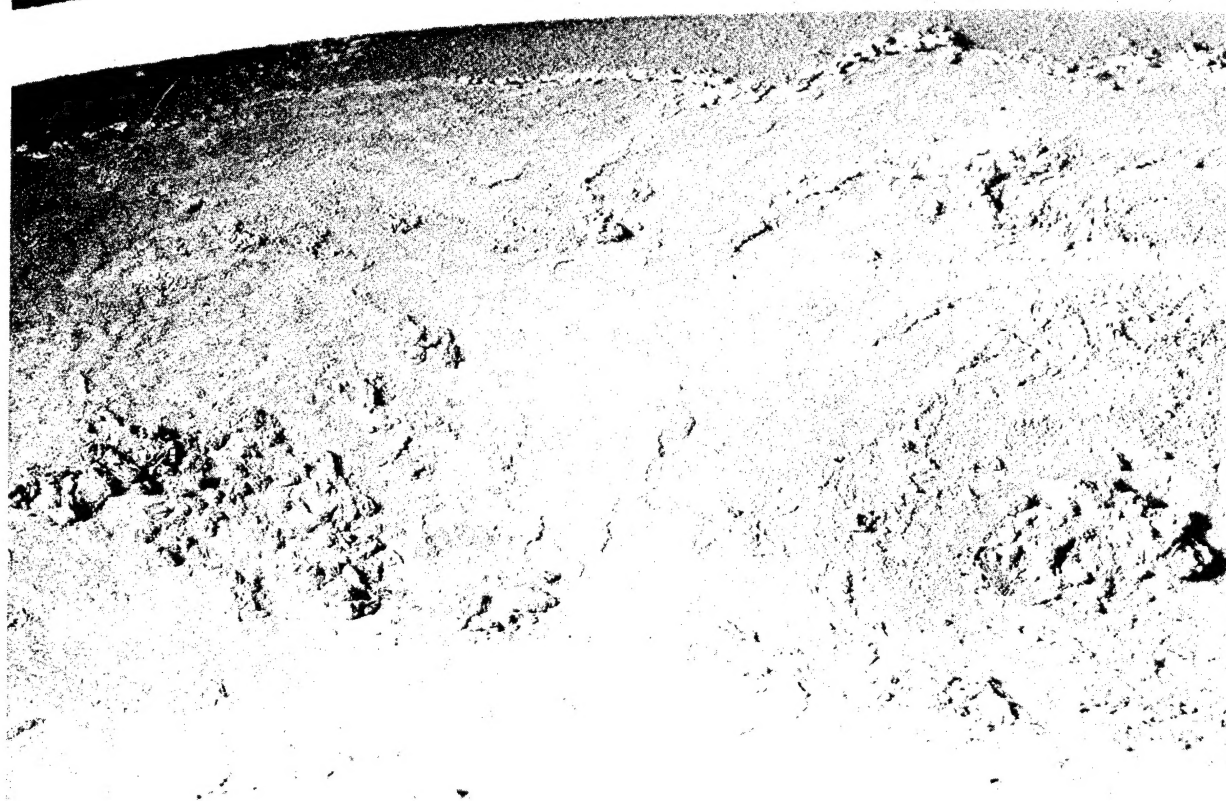
4. It is probable that some of the damage in boiler 1B was due to chemical attack, but that the actual burnout of the tubes was due to suspensions from the mud drum being flushed out into the generator tubes, and adhering to the heated surfaces. The fact that the deposits were not uniform, but were very spotty, points to this probability, as does the fact that there is a decrease in total deposit as a function of distance from the mud drum. The ultimate cause of the failures could have been insufficient blowdown following the introduction of large excesses of water-treatment chemicals.

- Fig. 5 - 1B Boiler - RW No. 30, Waterside (Section containing two bulges). Note configuration of deposits around bulges and massive deposits over the actual bulges. (2-1/4 X).

Fig. 5 - 1B Boiler - RW No. 30, Waterside
(Section containing two bulges). Note config-
uration of deposits around bulges and massive
deposits over the actual bulges. (2-1/4X).

1. Strict adherence to specified water chemistry.
2. Frequent and copious blowdowns to remove solids from the mud drum.
